# Investigation Report

### Clean Water Branch

ID #: PA0991E

Facility: Waste Management Hawaii/CCH

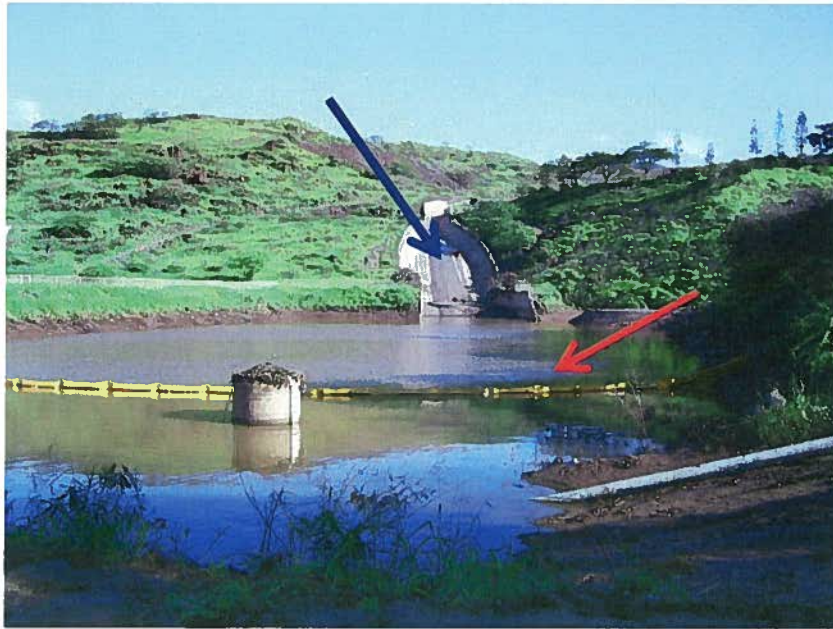
Photograph # 1

1) ☐ The DOH-CWB and DOH-SHWB representatives met at the Landfill at approximately 9:20 am. J. Frey and J. Lottig were present at the start of the inspection. To begin the inspection, the Landfill's detention basin (Photograph 1) was observed. At the time of inspection, no outflow of the detention basin's contents was observed. Chris Sprague from the CCH was present at the Landfill at the time and stated that there was no flow out of the detention basin for two (2) days. The area between the detention basin and Farrington Highway appeared much cleaner (Photograph 2). A minimal flow was observed running down the Landfill's concrete lined drainage channel.

Description: View of the Landfill's detention basin. The basin had a floating boom (Red Arrow) installed at the time of inspection. A minimal flow in the concrete lined channel (Blue Arrow) was observed.

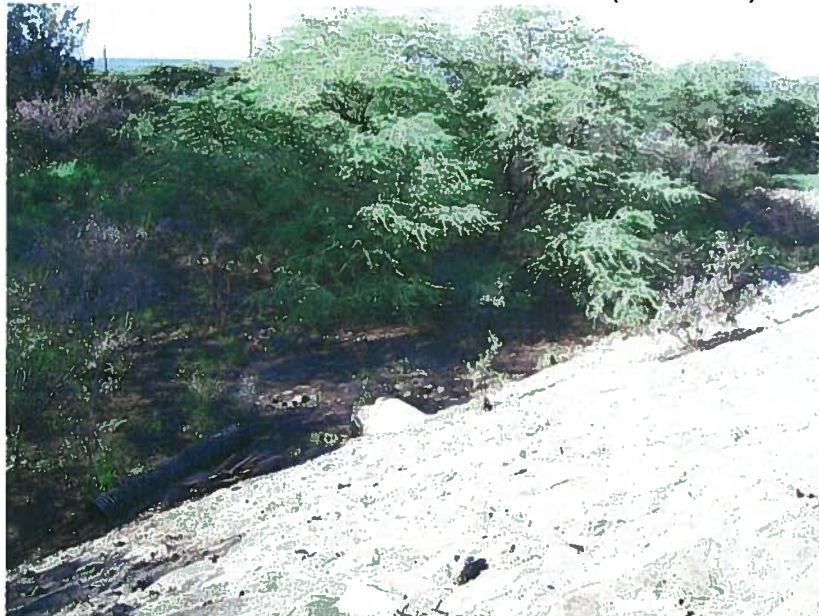
Photograph # 2

Description: View of the area between the Landfill and Farrington Highway. The area appeared much cleaner than during the previous inspection performed on January 13, 2011.

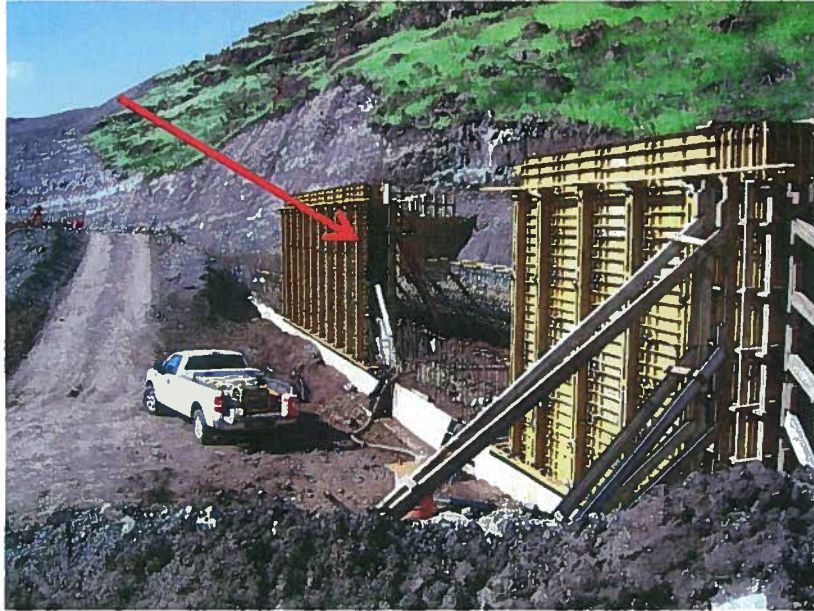
Photograph # 3

14) After statements by Waste Management Hawaii representatives, the E6 area of the Landfill was inspected. The new headwall (Photograph 3), located above the Landfill's expansion area, was observed. The headwall was being constructed in an area north of the E6 cell. The headwall is part of a storm water diversion system designed to prevent storm water run-on from flowing into the active areas of the Landfill (Photograph 4). Waste Management Hawaii representatives reiterated that had the series of storms starting from December 18, 2010

Description: View of the Landfill's storm water diversion headwall (Red Arrow). The headwall was under construction at the time of inspection.

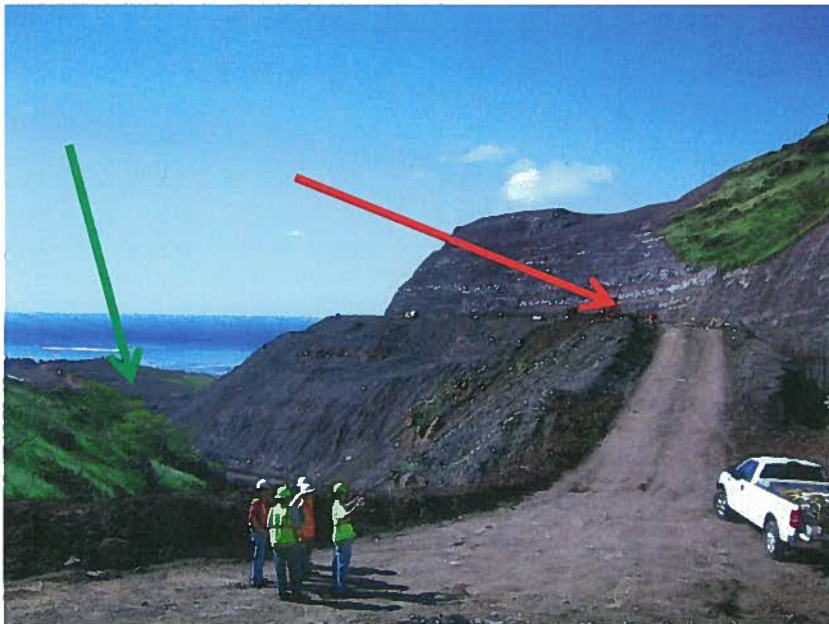
Photograph # 4

Description: View of the area where storm water will be diverted once the storm water diversion system is completed. Storm water will be routed around the ridge (Red Arrow) and connect to the Hobas pipe to bypass the E6 cell (Green Arrow).

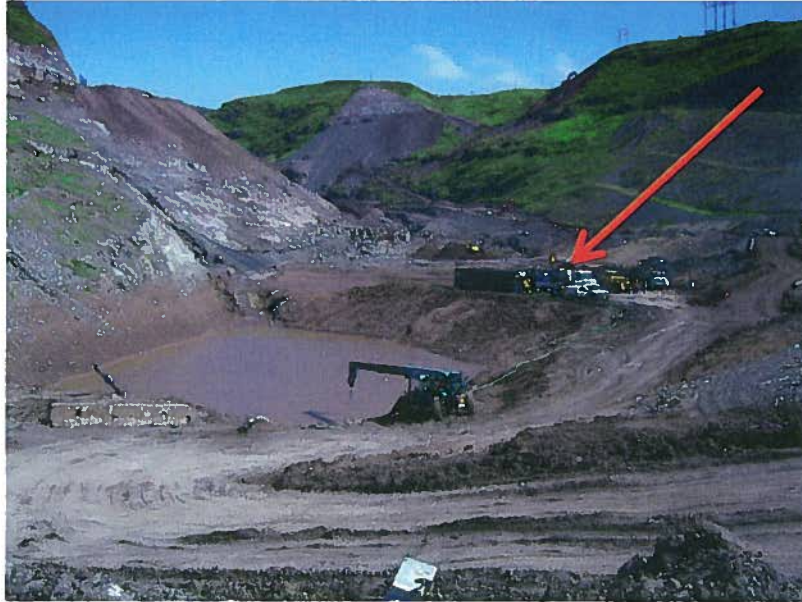
Photograph # 5

15) ☐ The E6 cell (Photograph 5) had much lower water levels at the time of inspection. The north side of the E6 cell was being repaired at the time of inspection. The water level in the south side of the E6 cell was being lowered via pumping. Water pumped from the E6 cell was being taken to a wastewater treatment plant for disposal. What appeared to be off gassing was observed within the E6 cell. At several points throughout the liquid still present in the E6 cell, continuous streams of bubbles were observed.

Description: View of the E6 cell. The water levels within the E6 cell were much lower due to the pumping of the E6 cell's contents to trucks (Red Arrow) for disposal at a wastewater treatment plant.

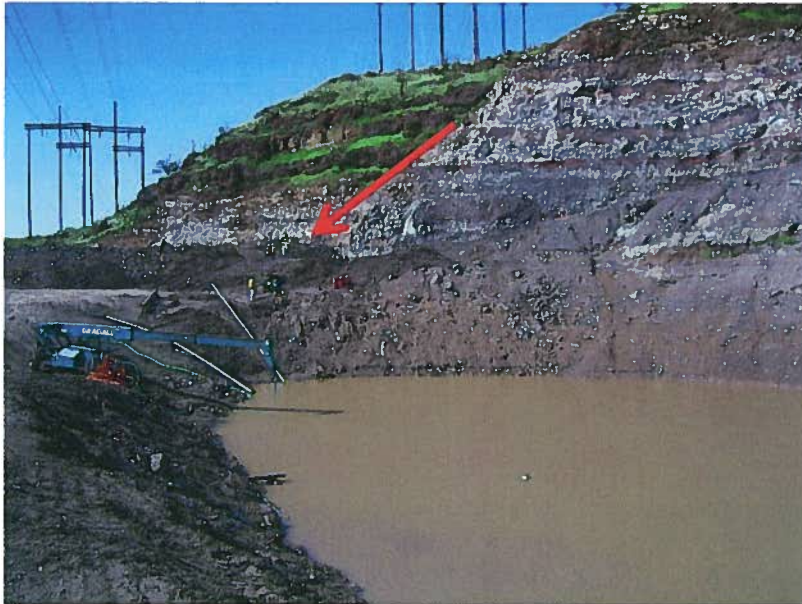
Photograph # 6

Description: View of the southwest side of the E6 cell. The opening to the Hobas pipe (Red Arrow) was located on the southwest corner of the E6 cell.

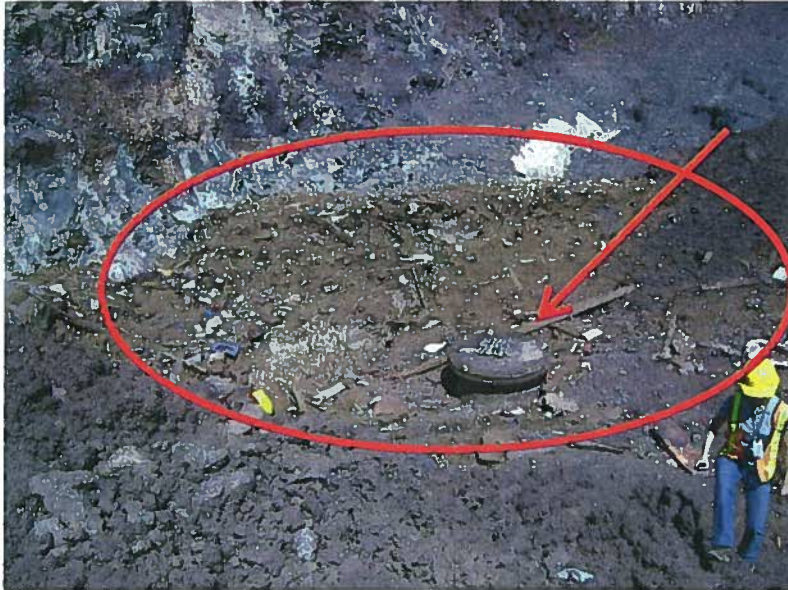
Photograph # 7

16) ☐ The opening to the Hobas pipe, which is located on the southwest side of the E6 cell, (Photograph 6) was observed during the inspection. The opening to the Hobas pipe was closed (Photograph 7) at the time of inspection. Significant amounts of solid waste and debris were observed in the area around the opening of the Hobas pipe. Solid waste observed in the area included medical waste such as intravenous bags (IV) (Photographs 8 and 9) and syringes (Photograph 10).

Description: View of the opening of the Hobas pipe located on the southwest side of the E6 cell. The Hobas pipe was closed (Red Arrow) at the time of inspection. Solid waste (Red Circle) was observed deposited around the opening to the Hobas pipe.

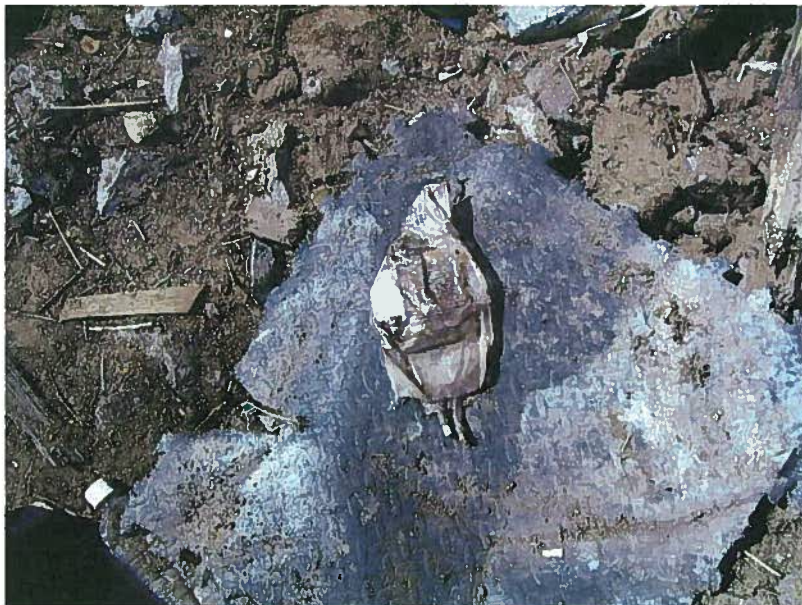
Photograph # 8

Description: View of an IV bag observed in the solid waste deposited around the opening of the Hobas pipe. Solid waste including medical waste was observed in the area.

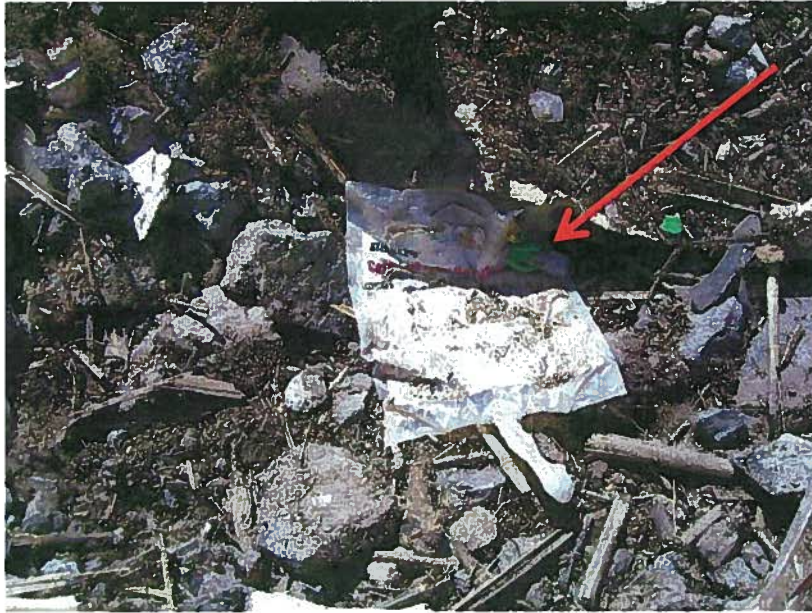
Photograph # 9

Description: View of medical waste (Red Arrow) observed in the solid waste deposited around the opening to the Hobas pipe.

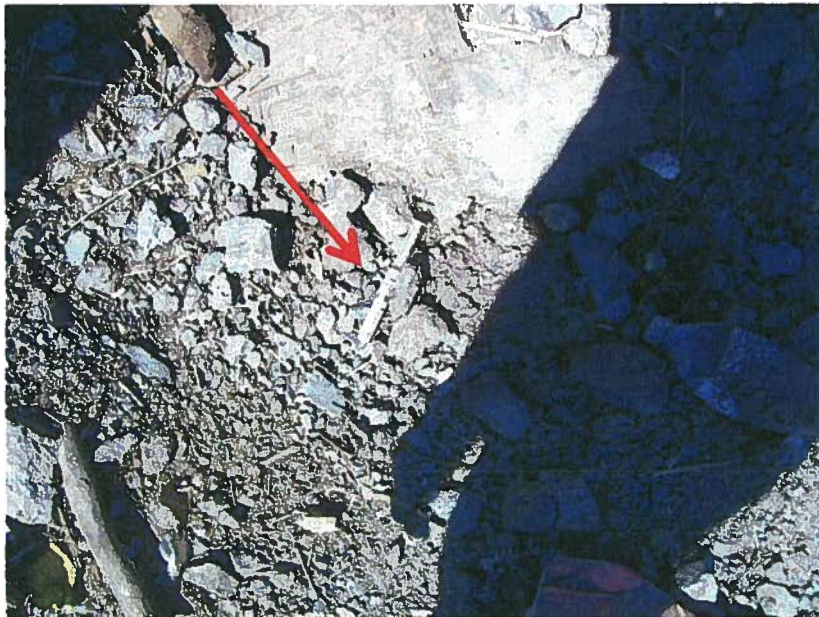
Photograph # 10

Description: View of a syringe (Red Arrow) observed in the area around the opening to the Hobas pipe.

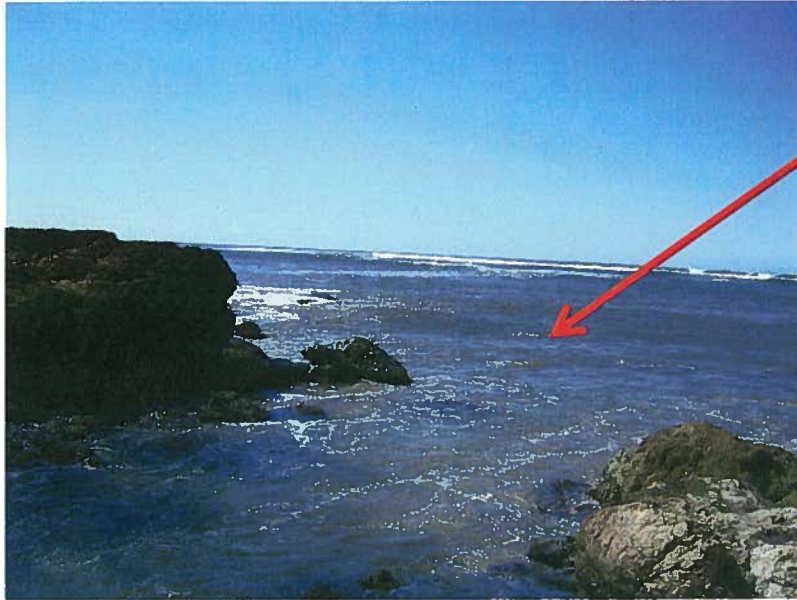
Photograph # 11

17) ☐ The receiving water around the Landfill's outfall (Photograph 11) was observed after the inspection of the Landfill on January 20, 2011. A turbid plume was observed around the Landfill's outfall. The plume appeared to extend towards the south. A warning sign was observed near the Landfill's outfall (Photograph 12).

Description: View of the receiving water near the Landfill's outfall. A turbid plume (Red Arrow) extended from the Landfill's outfall into receiving waters.

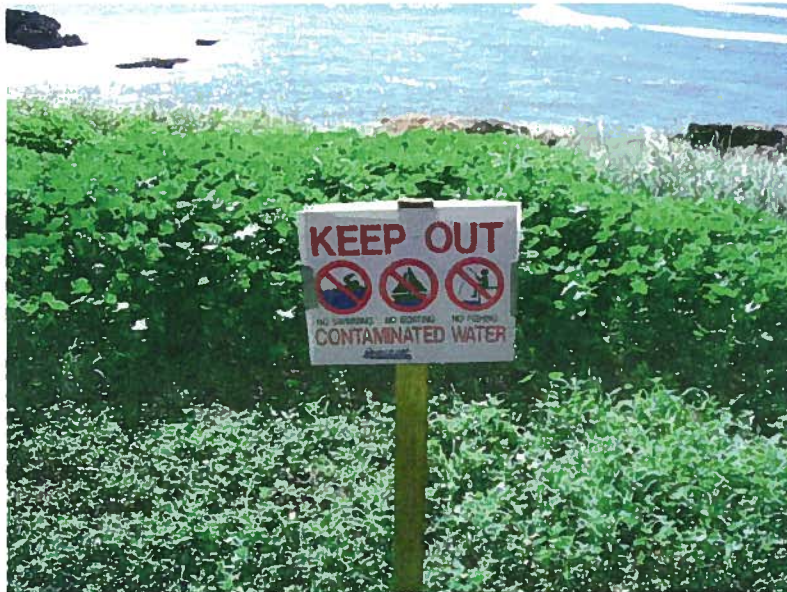
Photograph # 12

Description: View of a warning sign posed near the Landfill's oufall.

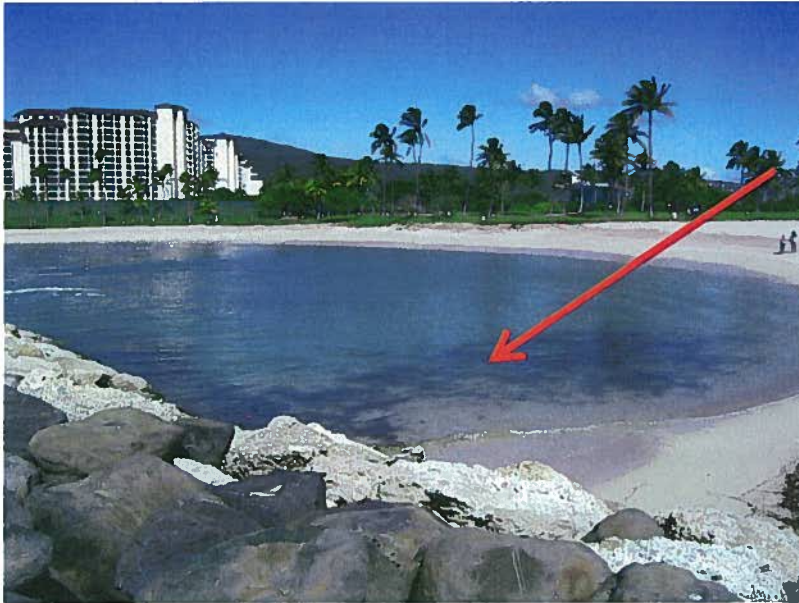
Photograph # 13

18) ☐ The Ko Olina Lagoon 4 (Photograph 13) was observed during the inspection. The water quality within Lagoon 4 appeared to have improved significantly as compared to the water quality observed on January 13, 2011. Ko Olina representatives stated that floatable debris was still being collected within the Ko Olina lagoons.

Description: View of Ko Olina Lagoon 4. Debris (Red Arrow) was still being washed into the Lagoon at the time of inspection.

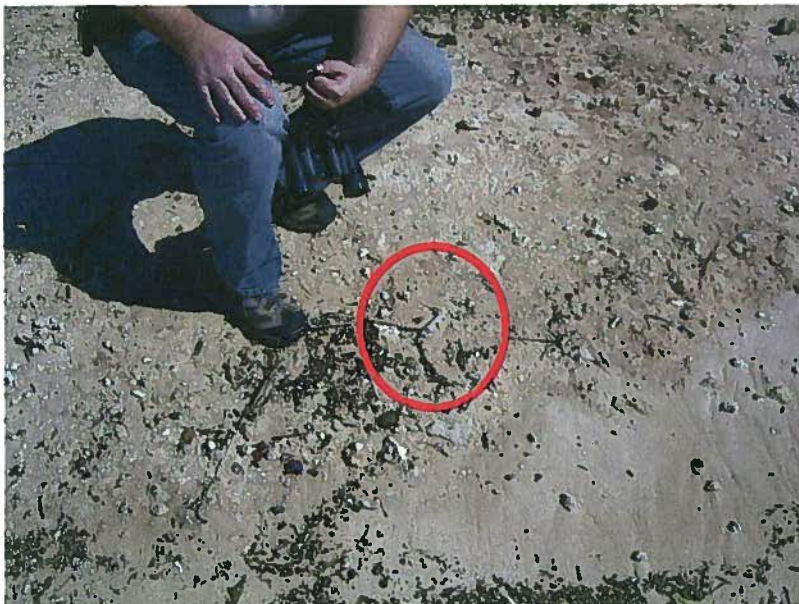
Photograph # 14

19) ☐ Eddie Belluomini, Operations Manager for Ko Olina Operations, was present at Lagoon 4. According to E. Belluomini, debris and medical waste was still being collected within the Ko Olina property and in the area immediately south of Ko Olina's property. E. Belluomini stated that the amount of medical waste that was washing up on Ko Olina's property was diminishing each day. A syringe (Photograph 14) was observed in the high water mark at Lagoon 4 during the inspection.

Description: View of a syringe observed in the high water mark at the Ko Olina Lagoon 4 at the time of inspection. Ko Olina representatives stated that they had found medical waste along the Ko Olina property on the day of inspection.
